# QUINN CONSTRUCTION, INC.®

University of Notre Dame - Old Bowl Stadium, Lower/Old seating Bowl sections 1-36  
South Bend, Indiana

## PROJECT DESCRIPTION

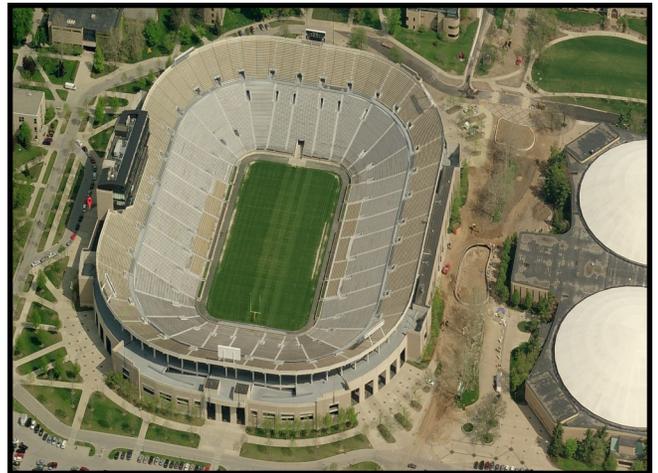
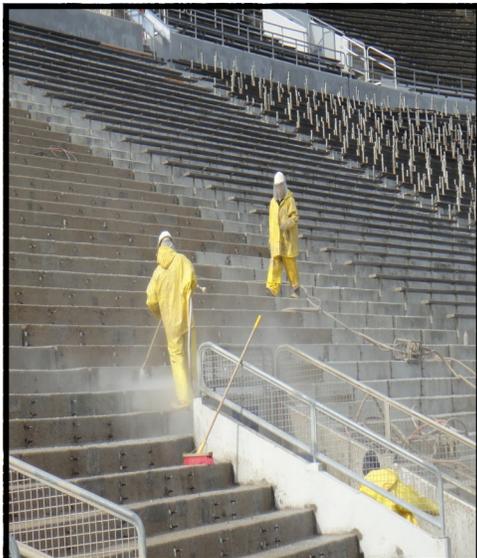
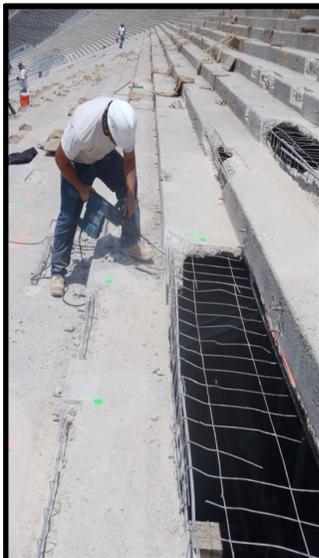
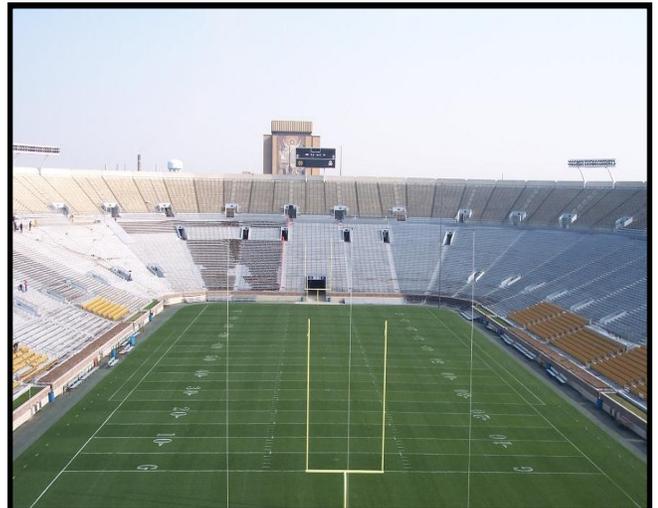
Repaired the deteriorated concrete on the topside and underside of stadium. Installed a waterproofed urethane coating to protect the structure.

- ◆ Removal, repainting, and storage of seating.
  - ◆ Erecting scaffolding to access the entire underside of the work area.
  - ◆ Hydro demolition to gently remove existing coatings and freeze/thaw deteriorated concrete without causing additional damage.
- ◆ Concrete repair using primarily form-and-pour repairs.
- ◆ Installation of a cementitious parge coat on all on-grade seating areas.
- ◆ Removal and replacement of expansion joints.
- ◆ Installation of a customized five-coat pedestrian traffic bearing waterproofing system on the elevated portion of the stands to prevent future water infiltration.

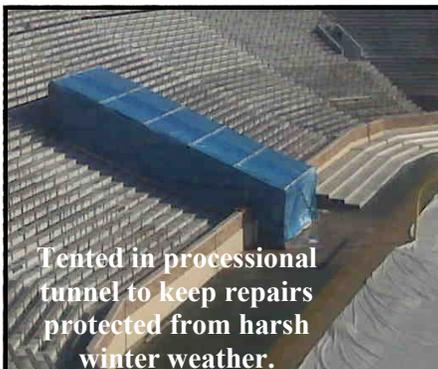
Tented in processional tunnel to keep repairs protected from harsh winter weather.

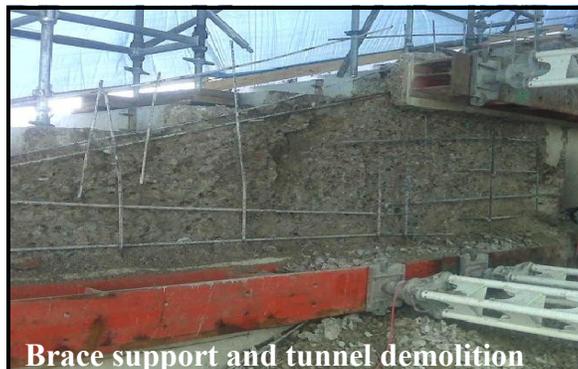
Brace support and tunnel demolition

- ◆ Removal of all unsound concrete.
- ◆ Shoring of tunnel walls.
- ◆ Forming and pouring new walls.
- ◆ Coating all walls and reinstalling handrails.
