Upper Uwchlan Township - Effluent Storage Tank Rehabilitation

OWNER: [Upper Uwchlan Township Municipal Authority](#)
ENGINEER: [ARRO Consulting, Inc.](#)

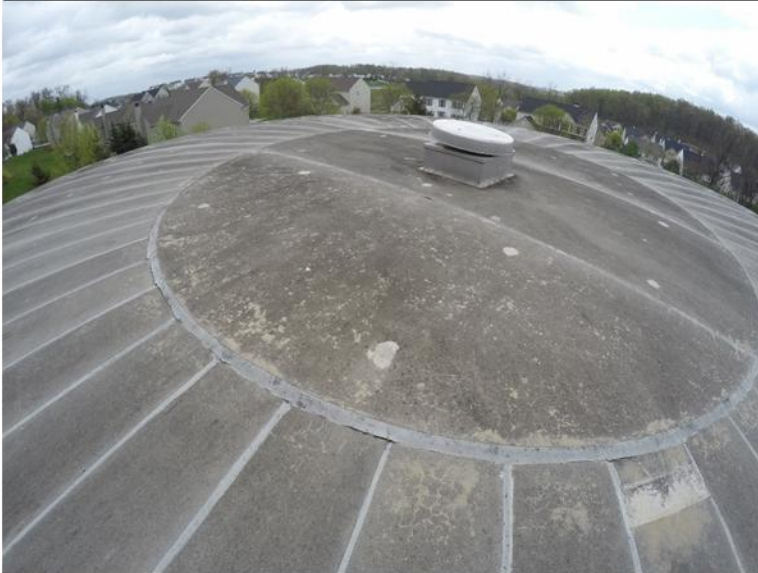
Weather and the freeze thaw cycle had allowed water to penetrate the roof and joint aspects of the 3 treatment tanks for Upper Uwchlan Township.

Quinn was called upon to remove the weathered sealant, sound out any suspect spall areas, and replace back in with high performance mortar materials.

Detailing was required for the lifting lugs and jacking pockets prior to being sealed off to remove future damage by expansion.

Areas that showed signs of efflorescence were cleaned and treated prior to being grouted.
